Example 17 – Structural Collapse

Victorian terrace occupied by the owner with vulnerable occupants on benefits

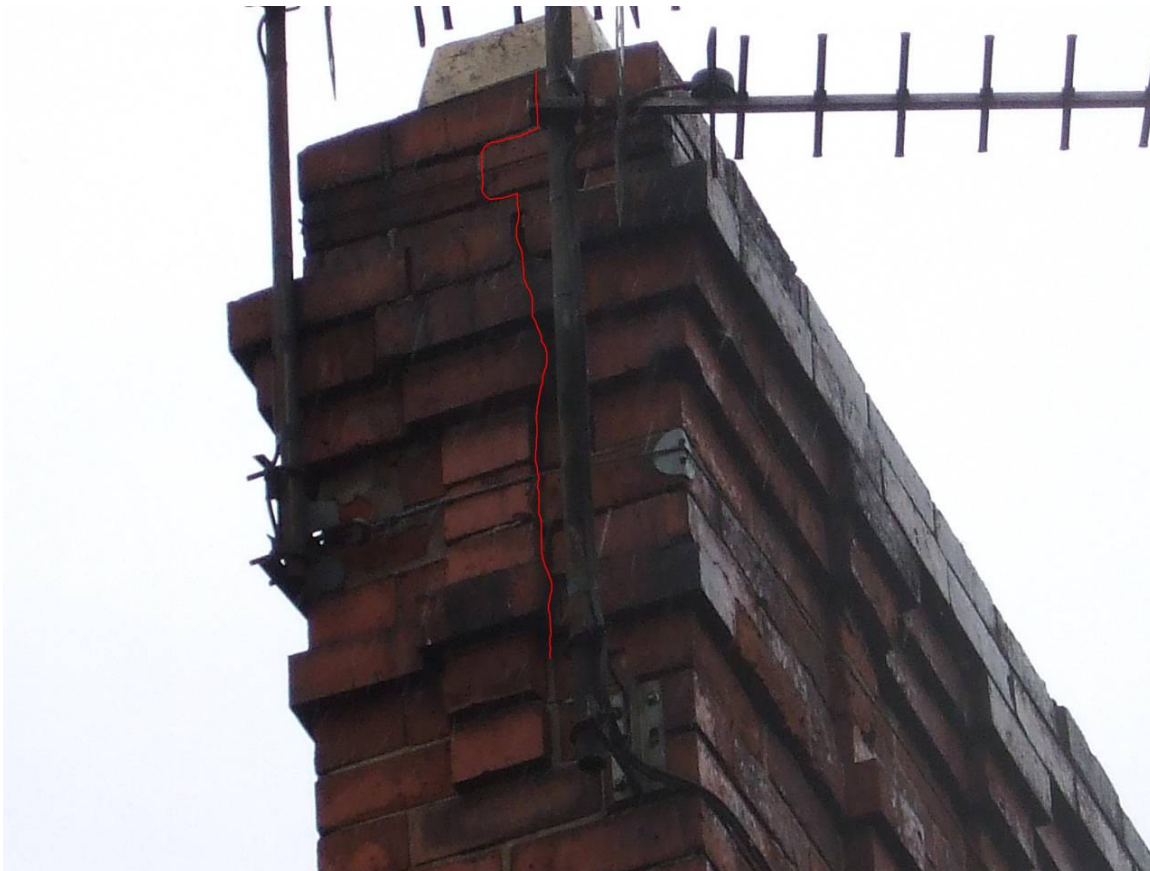
This large chimney is shared by 2 properties and fails the decent homes standard. There is a crack down the centre of the chimney approximately 1" wide (along red line). It appears that the chimney is held together by the aerial banding, although it is very difficult to tell if partial or total collapse would be likely.

Justification **The chimney has a 1" crack down it which may break and collapse**

Justification **If this chimney falls it would cause considerably more harm than the average due to the height it would fall from, and the weight of the stack.**

RATING **A** **B** **C** D E F G H I J Score (if calculated) **1867**
 <5000 2000 1000 500 200 100 50 20 10>

Enforcement Action:
 The group decided that it would be difficult to determine the severity of the defect without having the chimney examined by a structural engineer. Some would use the councils structural engineers to obtain a professional opinion and others would have served an improvement notice requiring the landlord to have this work done, and to carryout any work deemed necessary. This was dependant on individual councils procedures and personnel availability.
