HHSRS Worked Examples from East Midlands Standardisation Working Group, 5 September 2006

Example 7 – Entry by Intruders

Report of inspection

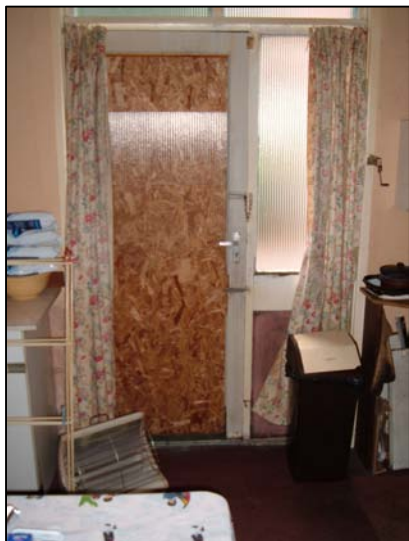
- a. The front door is a 2 lever mortice with viewing chain and yale lock, there is a glazed window to the side of the door which is not toughened or safety glass
- b. The rear door has been broken into in the past and is temporarily boarded. The lock was not accessible but is not a high security lock. There is an ordinary glazed window to the side of the door.
- c. There is no operating burglar alarm.

2 lever mortise lock to front door, with glass side panel
Rear door has been broken into recently and is now temporarily boarded, also has glass side panel
No burglar alarm
Area has high crime rate
Rear door only overlooked by two houses

Although this resulted in a category 2 hazard, it was decided that action would still be taken immediately to secure the property
