**HHSRS Worked Examples from East Midlands
Standardisation Working Group
6 March 2008**

Example 15 – Food Safety

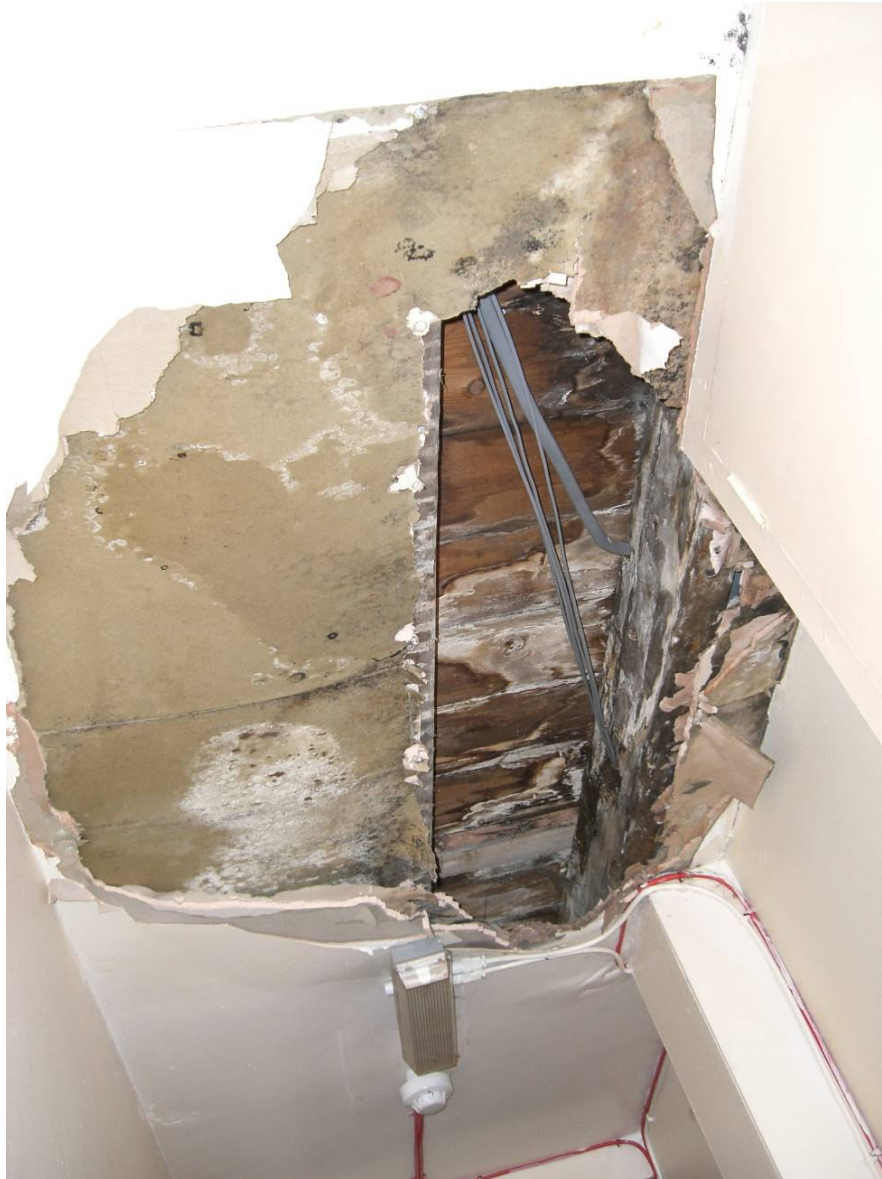
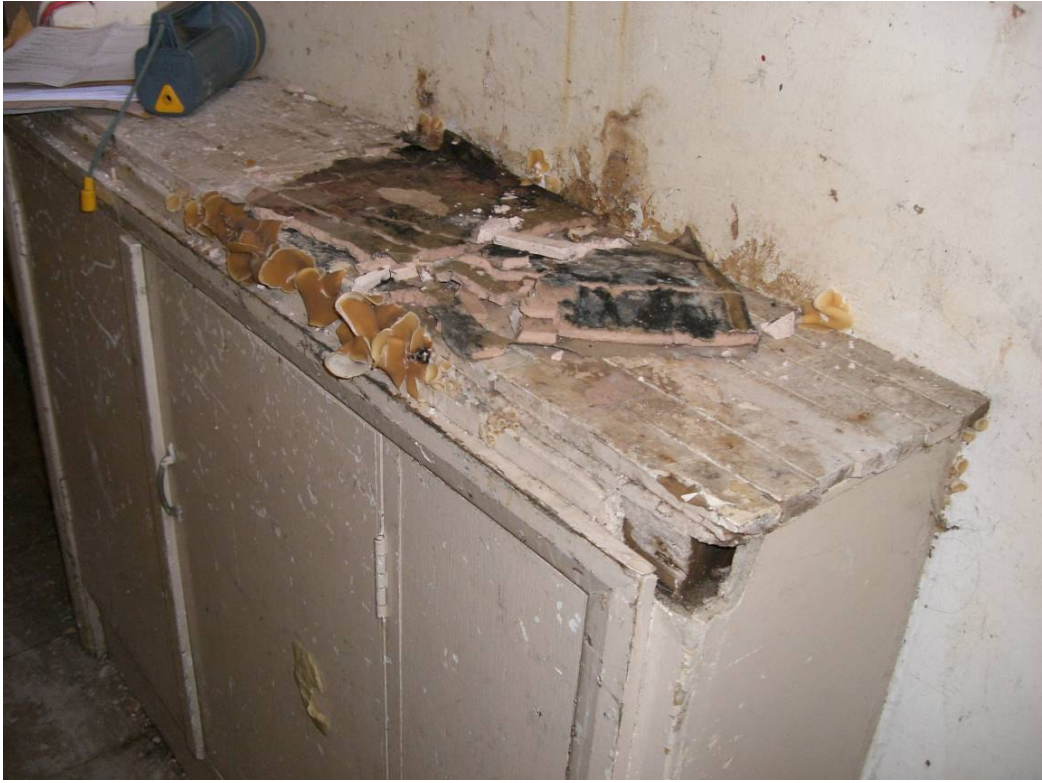
1950's two story semi detached house occupied by a single man. This is the kitchen ceiling and kitchen side board. Directly above the kitchen is the bathroom in which the pipe to the bath has been leaking.

HAZARD & No **Food Safety** **16** Item/s **Collapsed ceiling in kitchen**

Justification
Lack of cleansable work surface in kitchen
Disrepair to kitchen ceiling
Poor quality storage facilities
No tiled splashback

Justification
Due to the extremely poor conditions in the kitchen, any food poisoning caused is likely to be more severe than the average.

Enforcement Action:
The group decided that the most appropriate course of action would be to serve an Improvement notice requiring works to be carried out to the kitchen.
