HHSRS Worked Examples from East Midlands Standardisation Working Group, 5 September 2006

Example 7 – Entry by Intruders

Report of inspection

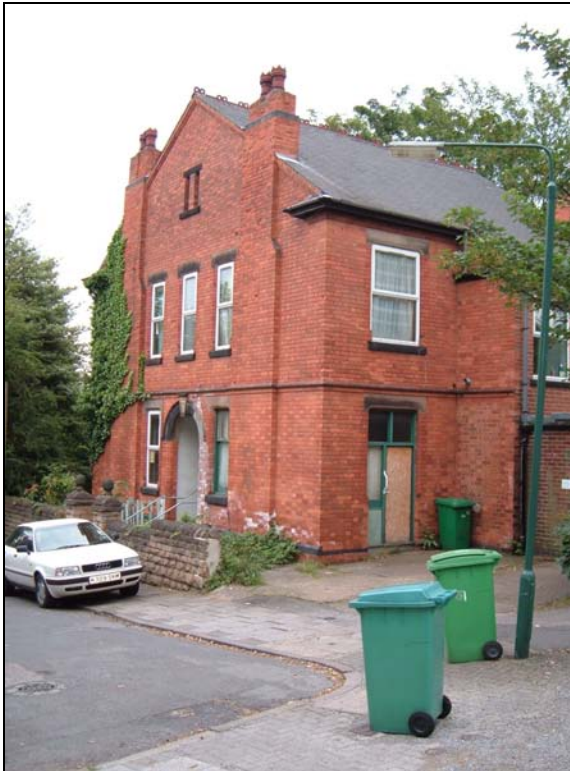
The property has been broken into in the past and the rear glass door to the kitchen is partially boarded up.

- a. The front door is a 2 lever mortice with viewing chain and yale lock, there is a glazed window to the side of the door which is not toughened or safety glass
- b. The rear door has been broken into in the past and is temporarily boarded. The lock was not accessible but is not a high security lock. There is an ordinary glazed window to the side of the door.
- c. There is no operating burglar alarm.

2 lever mortise lock to front door, with glass side panel
Rear door has been broken into recently and is now temporarily boarded, also has glass side panel
No burglar alarm
Area has high crime rate
Rear door only overlooked by two houses

Although this resulted in a category 2 hazard, it was decided that action would still be taken immediately to secure the property
